**FEASIBILITY ANALYSES OF  
STREAM AND WETLAND RESTORATION ALTERNATIVES  
FOR WALDEN POND  
Richland County, SC**

Prepared for:  
Richland County Conservation Commission  
2020 Hampton Street  
3rd Floor, Room 3063A  
Columbia, SC 29204

Prepared by:  
WK Dickson & Co., Inc.  
1213 W. Morehead Street  
Charlotte, NC 704-334-5348

May 20, 2021

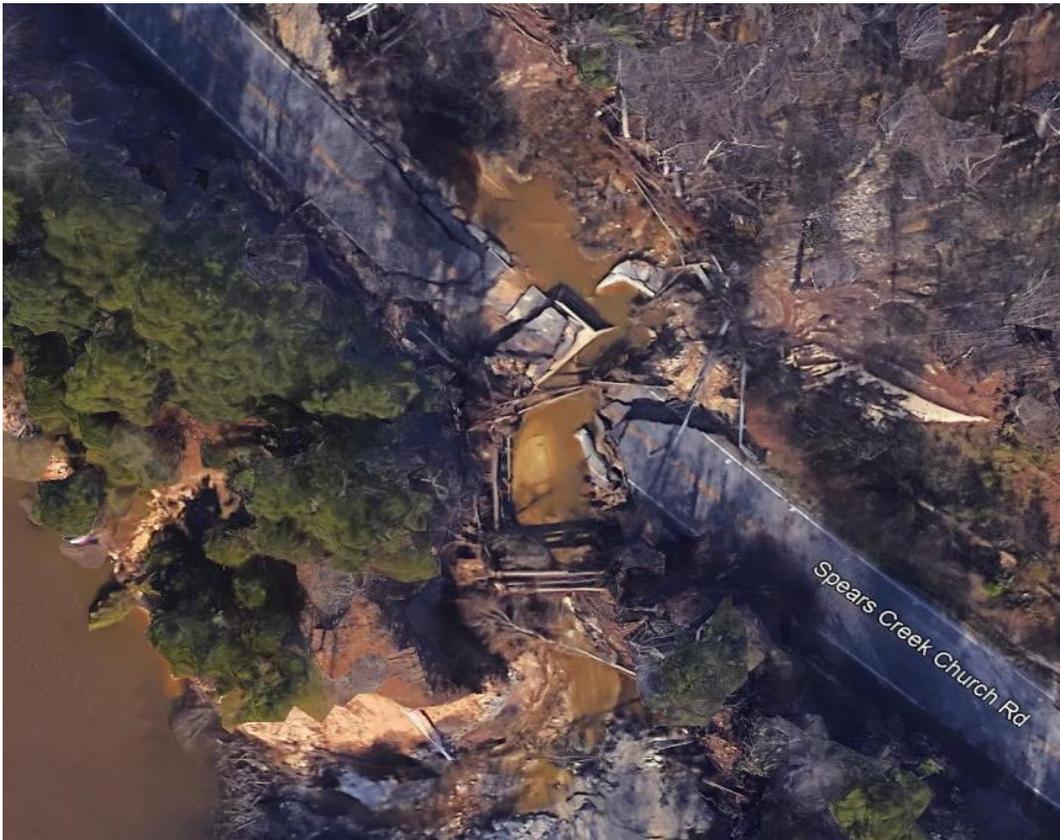
Damage to private property and public infrastructure was severe. There were 36 dam failures across the state, including at Walden Pond and another dam about 0.6 miles upstream on Spears Creek. Failure of the Walden Pond dam destroyed a section of Spears Creek Church Road (S 40-53). Massive amounts of sediment were evacuated from the pond and deposited downstream of the road into the Spears Creek channel and across its floodplain.

*Figure 2. Walden Pond dam breach and road washout after October 2015 floods (Google Earth Pro).*

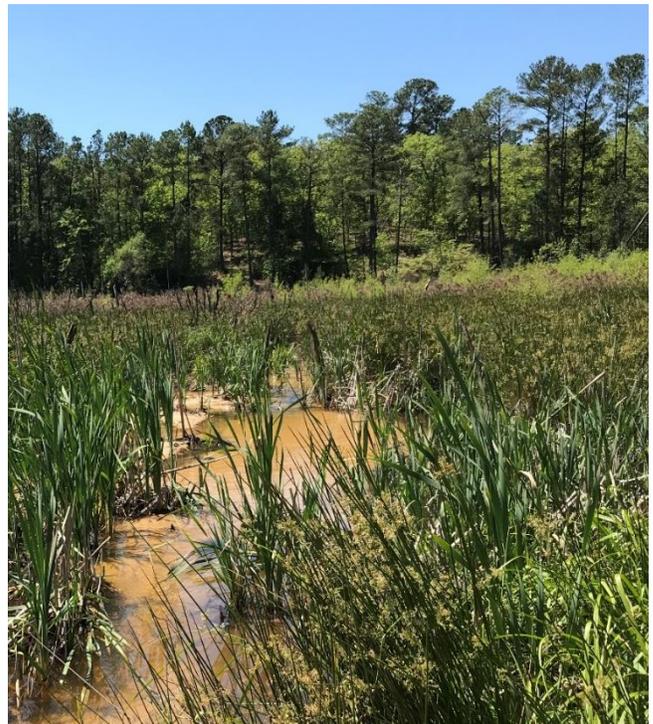
*Figure 3. Lush emergent wetland vegetation has colonized the upper 2/3 of Walden Pond. Also note recent sediment deposition in one of the characteristic braids of Spears Creek.*

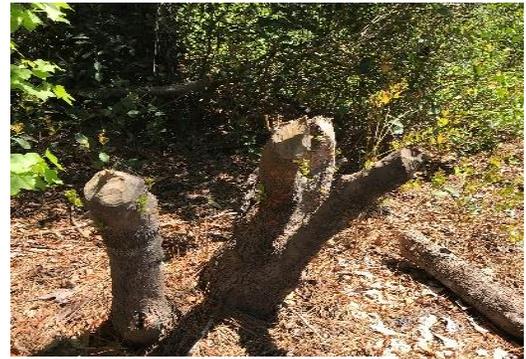
Figure 5. Recent beaver activity near Walden Place.

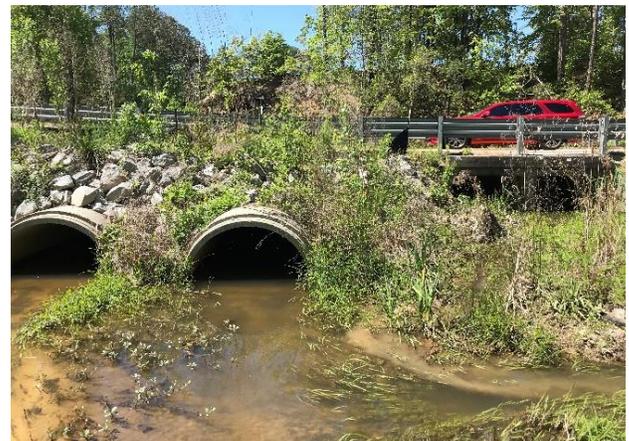
The riser and outfall culvert at Walden Pond appear to be in good condition although water no longer enters the structure. Spears Creek now flows easterly through the breach at the southeast corner to the bottom of the dam, which is also near the bottom of the fill slope that supports Spears Creek Church Road. The stream turns abruptly to the north-northwest and flows in the V-shaped area between the dam and the roadway fill slope. The new 60 inch concrete culverts were installed adjacent to the pre-existing box culvert during SCDOT roadway repairs. At the new culverts, which convey flow to the east side of the road, the flow turns sharply to the right (east). As the stream is flowing parallel to the road, flow must turn 90° to enter the culverts. Pools appear to have been excavated during the repairs to facilitate this unnatural flow path. Significant amounts of sediment and woody debris have accumulated in the pools and culvert openings, and sediment deposition in the old box culvert severely restricts hydraulic capacity.

Figure 6. New 60" RCs at repaired crossing of Spears Creek Church Road. Note sediment deposition in older box culverts under car at right and side channel at bottom right. View is upstream from the east side of roadway.

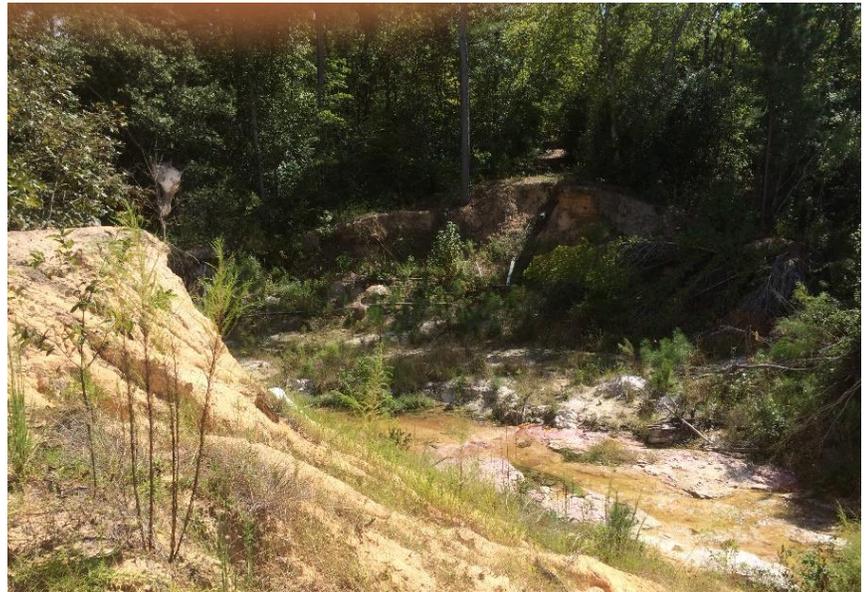
The dam failure appears to have originated at the emergency spillway at the southeast corner of the dam. Erosion through the breach was not uniform: erosion on the upstream face of the dam ranged from 90 to 150 feet with the greater erosion higher up the embankment. At the crest, the width of the breach is about 75 feet while lower on the downstream face the breach is approximately 50 feet wide. A cross section measured through the breach is shown in Figure 8. The section was measured approximately along the line of a 6" diameter PVC pipe that was exposed and broken during the flood, but remnants of which lie nearly normal to the orientation of the dam and are visible on aerial images.

Figure 7. Southeasterly view through dam breach. Note active rilling of northern embankment and sparse vegetation along channel.

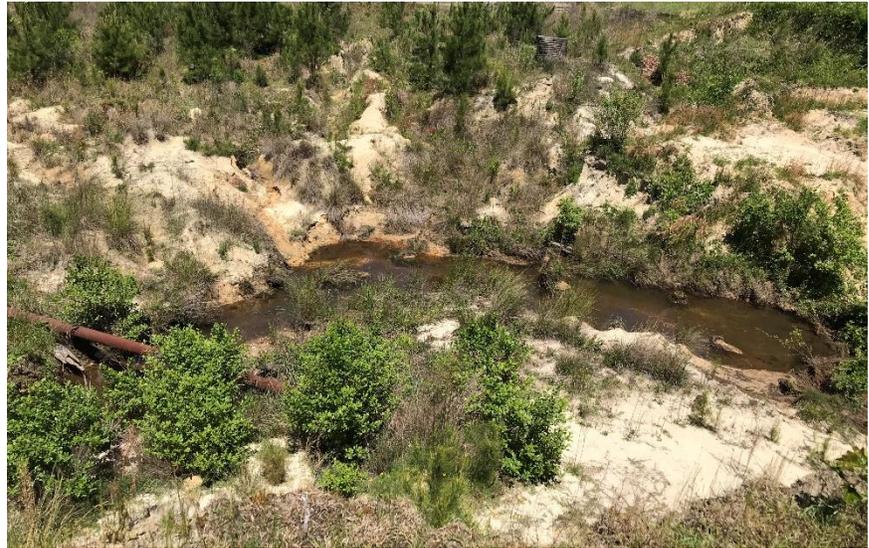
While the channel may be largely stable, the adjacent landscape is not. Vegetation in the formerly impounded area is very sparse. Rills and gullies are actively cutting into the valley side slopes. The channel appears to be transporting the upland sediment; no problematic in-channel storage was observed. Alder and willow are colonizing the banks, which should increase lateral stability.

*Figure 8. Rills and gullies contribute high sediment loads to Spears Creek at the former Delk pond, but no in-channel deposition is evident.*

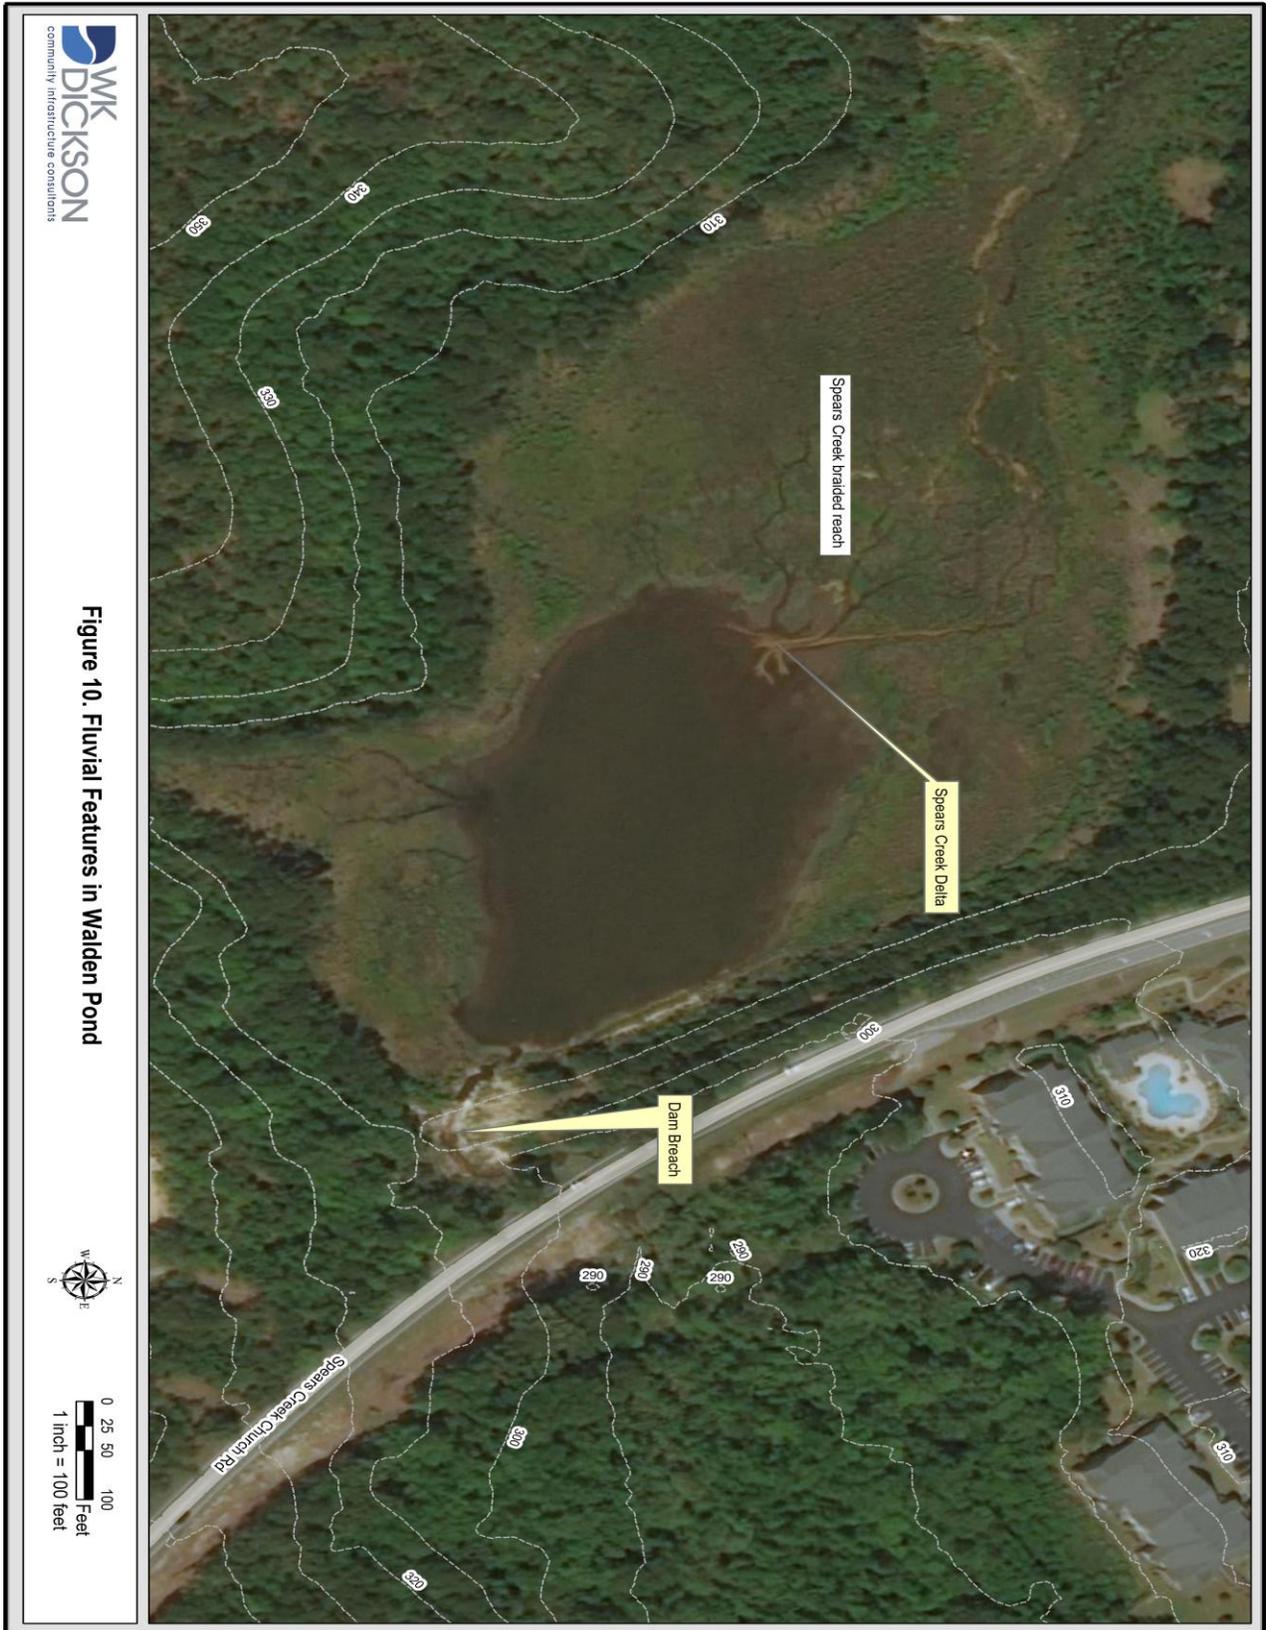
Braided channels typically form when the sediment supplied to a stream greatly exceeds the transport capacity of the stream, and such is the case in Walden Pond. As shown in Figure 10, Spears Creek is a braided system where it flows across the former pond bottom. A similar pattern is evident in the upper pond (not pictured) up to the tree line that delineates the upper boundary of this reach. Braided streams are highly dynamic as higher flows spread across the valley floor and work the sediments across and down valley. Due to the controlling influence of vegetation on streams in the eastern U.S., braided conditions are usually a transient response to episodic disturbance, as is the case here.

As can be observed in Figure 10, a larger channel carries much of the flow along the north side of the pond bottom. Brighter spots indicate sediment stored within this channel as (predominantly) lateral bars. This larger channel turns to the south above the remnant pool and loses all competence where local base level is encountered, producing a classic prograding delta. Observations in the field are confirmed on the aerial image: smaller channels, some of which exhibit bar storage, converge, intersect and diverge with the mainstem. It is hypothesized that this system is trending toward a single thread stream, although two or more other channels may persist as anabranches.

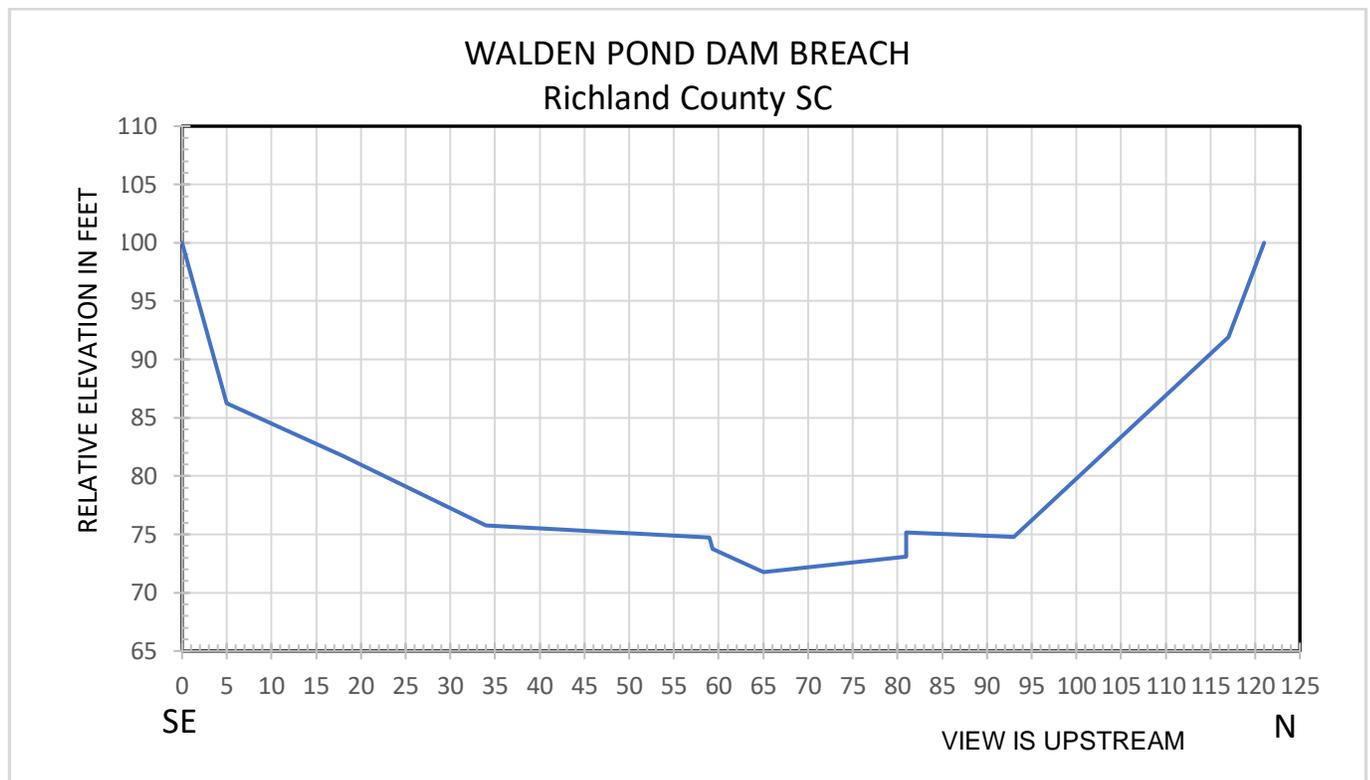
The new stream channel through the breach ranges from 8 to 24 feet in width, with the narrower segments corresponding to the localized steep gradients on the downstream face of the dam. The bed and bank materials of the channel are Cretaceous clays common to the region. The clay appears to be *in situ*. Two clay pits are mapped within one mile of Walden Pond on the 1972 topographic map, and the elevations indicated suggest the clay deposits probably underlie the dam. In addition, the dam material as seen at left in Figure 8 is yellowish-tan in color and contains fine sand and silt.

Through the breach, sediment transport capacity greatly exceeds sediment supply. No sediment is stored within the channel. No depositional features were observed on the relatively flat ground immediately adjacent to the channel, and vegetation in this area is extremely sparse. The overbank areas are erosional surfaces inundated by fast moving water several times per year. As will be discussed below, the hydraulic geometry of the stream is not consistent with the contributing drainage area. The stream is not in a quasi-equilibrium state and is actively adjusting the hydraulic geometry. A cross section measured through the dam breach is shown in Figure 11.

Figure 10. Cross section measured through the breach at Walden Pond dam.

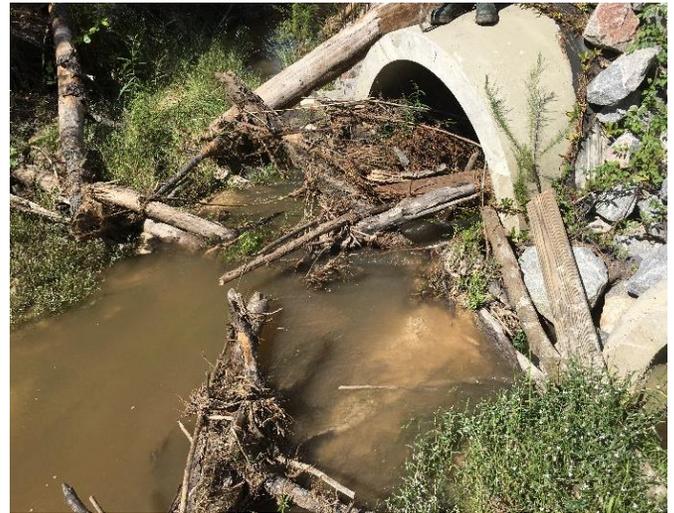
The current channel alignment directs flow at the roadway. While the channel turns to a northerly direction at the toe of the failed dam, high flows are likely to impose significant force on the road structure. In addition, the misalignment of the culverts to the channel flow has caused significant sedimentation and debris accumulation. Lacking design capacity and with nowhere else for floodwaters to go, the roadway could easily be overtopped. Overtopping could again contribute to a total failure. Therefore, a design imperative is to properly align the channel with the culverts for hydraulic efficiency and reduced erosional forces on the roadway embankments.

Figure 11. Sediment and debris blocking culvert upstream of Spears Creek Church Road .
