**FEASIBILITY ANALYSES OF  
STREAM AND WETLAND RESTORATION ALTERNATIVES  
FOR WALDEN POND  
Richland County, SC**

Prepared for:  
Richland County Conservation Commission  
2020 Hampton Street  
3rd Floor, Room 3063A  
Columbia, SC 29204

Prepared by:  
WK Dickson & Co., Inc.  
1213 W. Morehead Street  
Charlotte, NC 704-334-5348

May 20, 2021

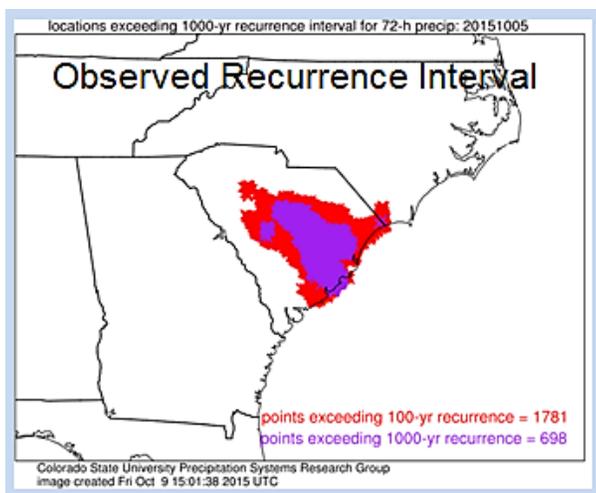
Figure 1. Hyetograph of October 2015 rain event in South Carolina (NOAA, 2016) .

Meteorological events during the period of October 1 through 5, 2015, resulted in record rainfall over large portions of South Carolina. Some areas experienced more than 20 inches of rainfall over the 5-day period with locally recorded rainfall rates of 2 inches per hour. This event occurred over developed areas in Columbia and Richland County where runoff rates are increased by impervious surface. Rainfall runoff was further amplified by high antecedent moisture conditions from previous rainfall, which reduced soil storage capacity. This historic rain event resulted in catastrophic flooding that caused nine fatalities in Richland County.

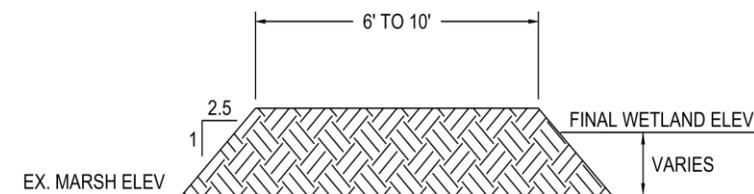
Figure 12. Marsh sill typical detail.

In addition, marsh sills are shown on the concept plan view and in Figure 13. The sills were primarily conceived to increase flood attenuation and would be strategically located to dissipate energy from high flows. The sills would also provide stable access for construction equipment. Finally, the sills can be configured to enhance recreational opportunities. Connections between sills that might not be required for engineering or habitat purposes can be installed to improve pedestrian access. This sills can also be expanded at strategic locations for wildlife viewing or picnic spots.

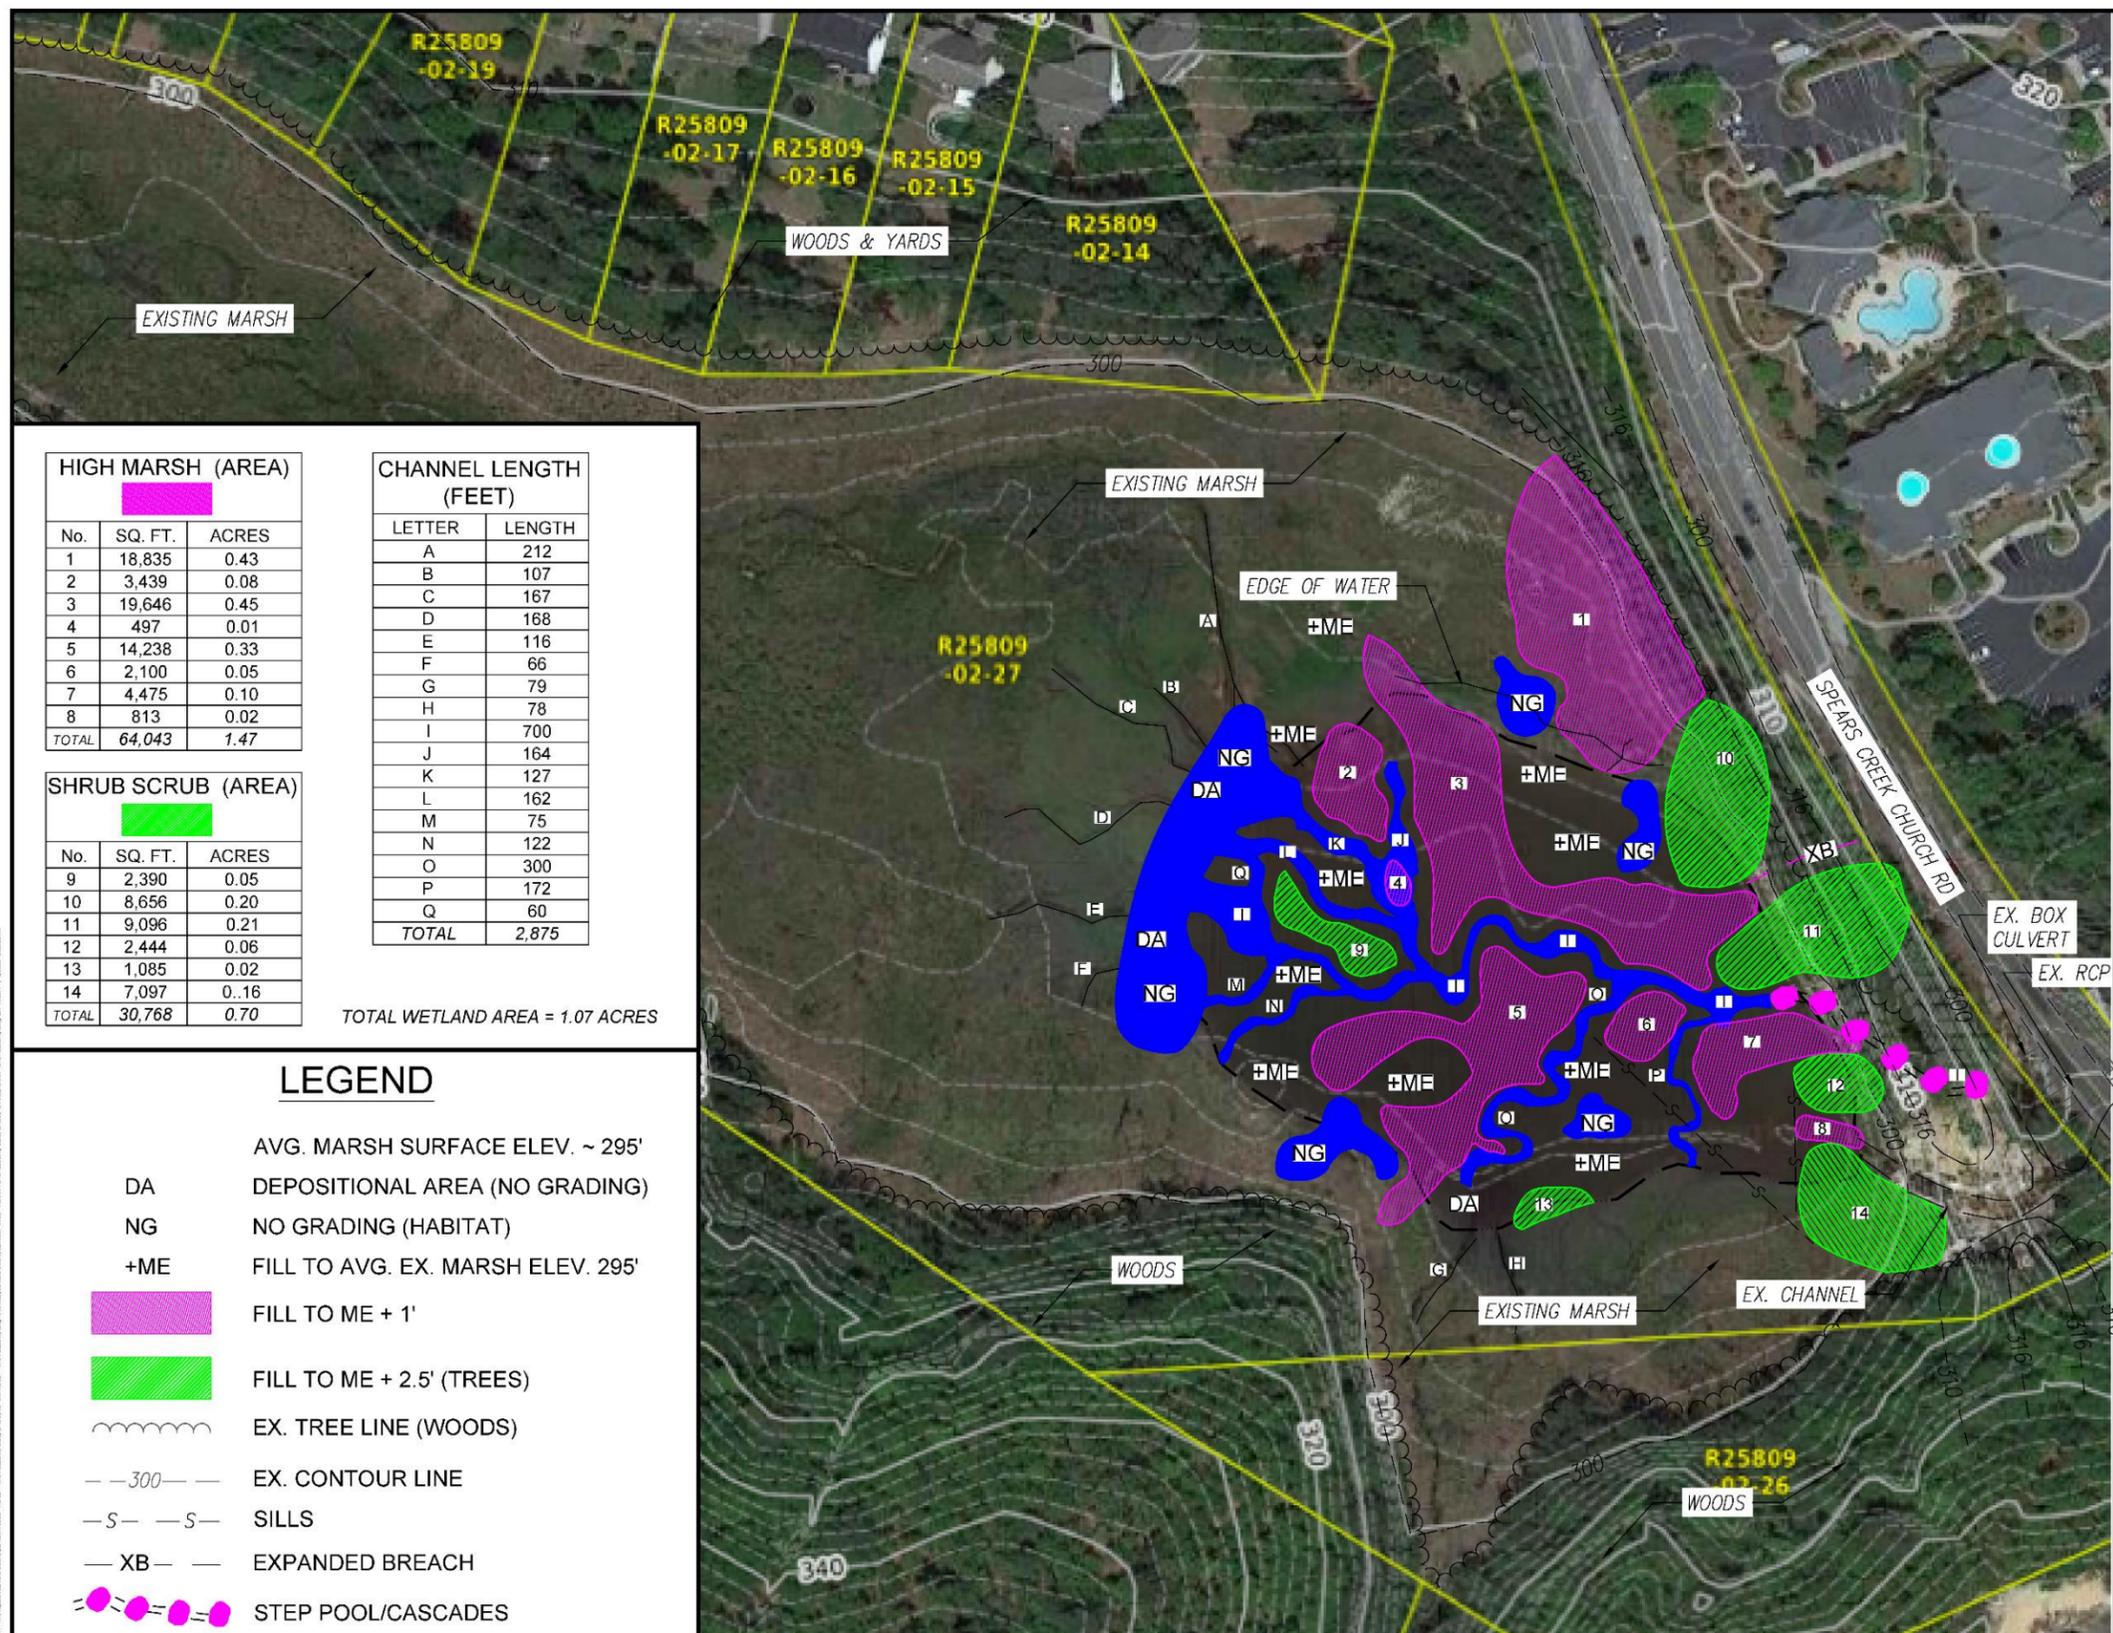
Figure 11. Alternative 1: multi-thread stream and wetland complex.

As shown in Figures 11 and 12, the conceptual design would preserve existing emergent wetland habitats and leave small pockets of open water. The existing channels upstream of the current pool would mostly be left to adjust naturally but would be constrained from excessive downcutting and concomitant increase in sediment by wood structures that would maintain the present low energy gradients. Wetland hydrology would be mostly conserved by maintaining the current marsh elevations as much as possible.

Downstream at the dam, the existing breach would be widened to accommodate a cascade/step-pool complex that would dissipate energy vertically while bringing the streambed down to the elevation of the culverts. Boulder cascades and step-pools do not naturally occur in the Coastal Plain geology; however they can be constructed here as an aesthetic amenity that also ensures robust channel stability.

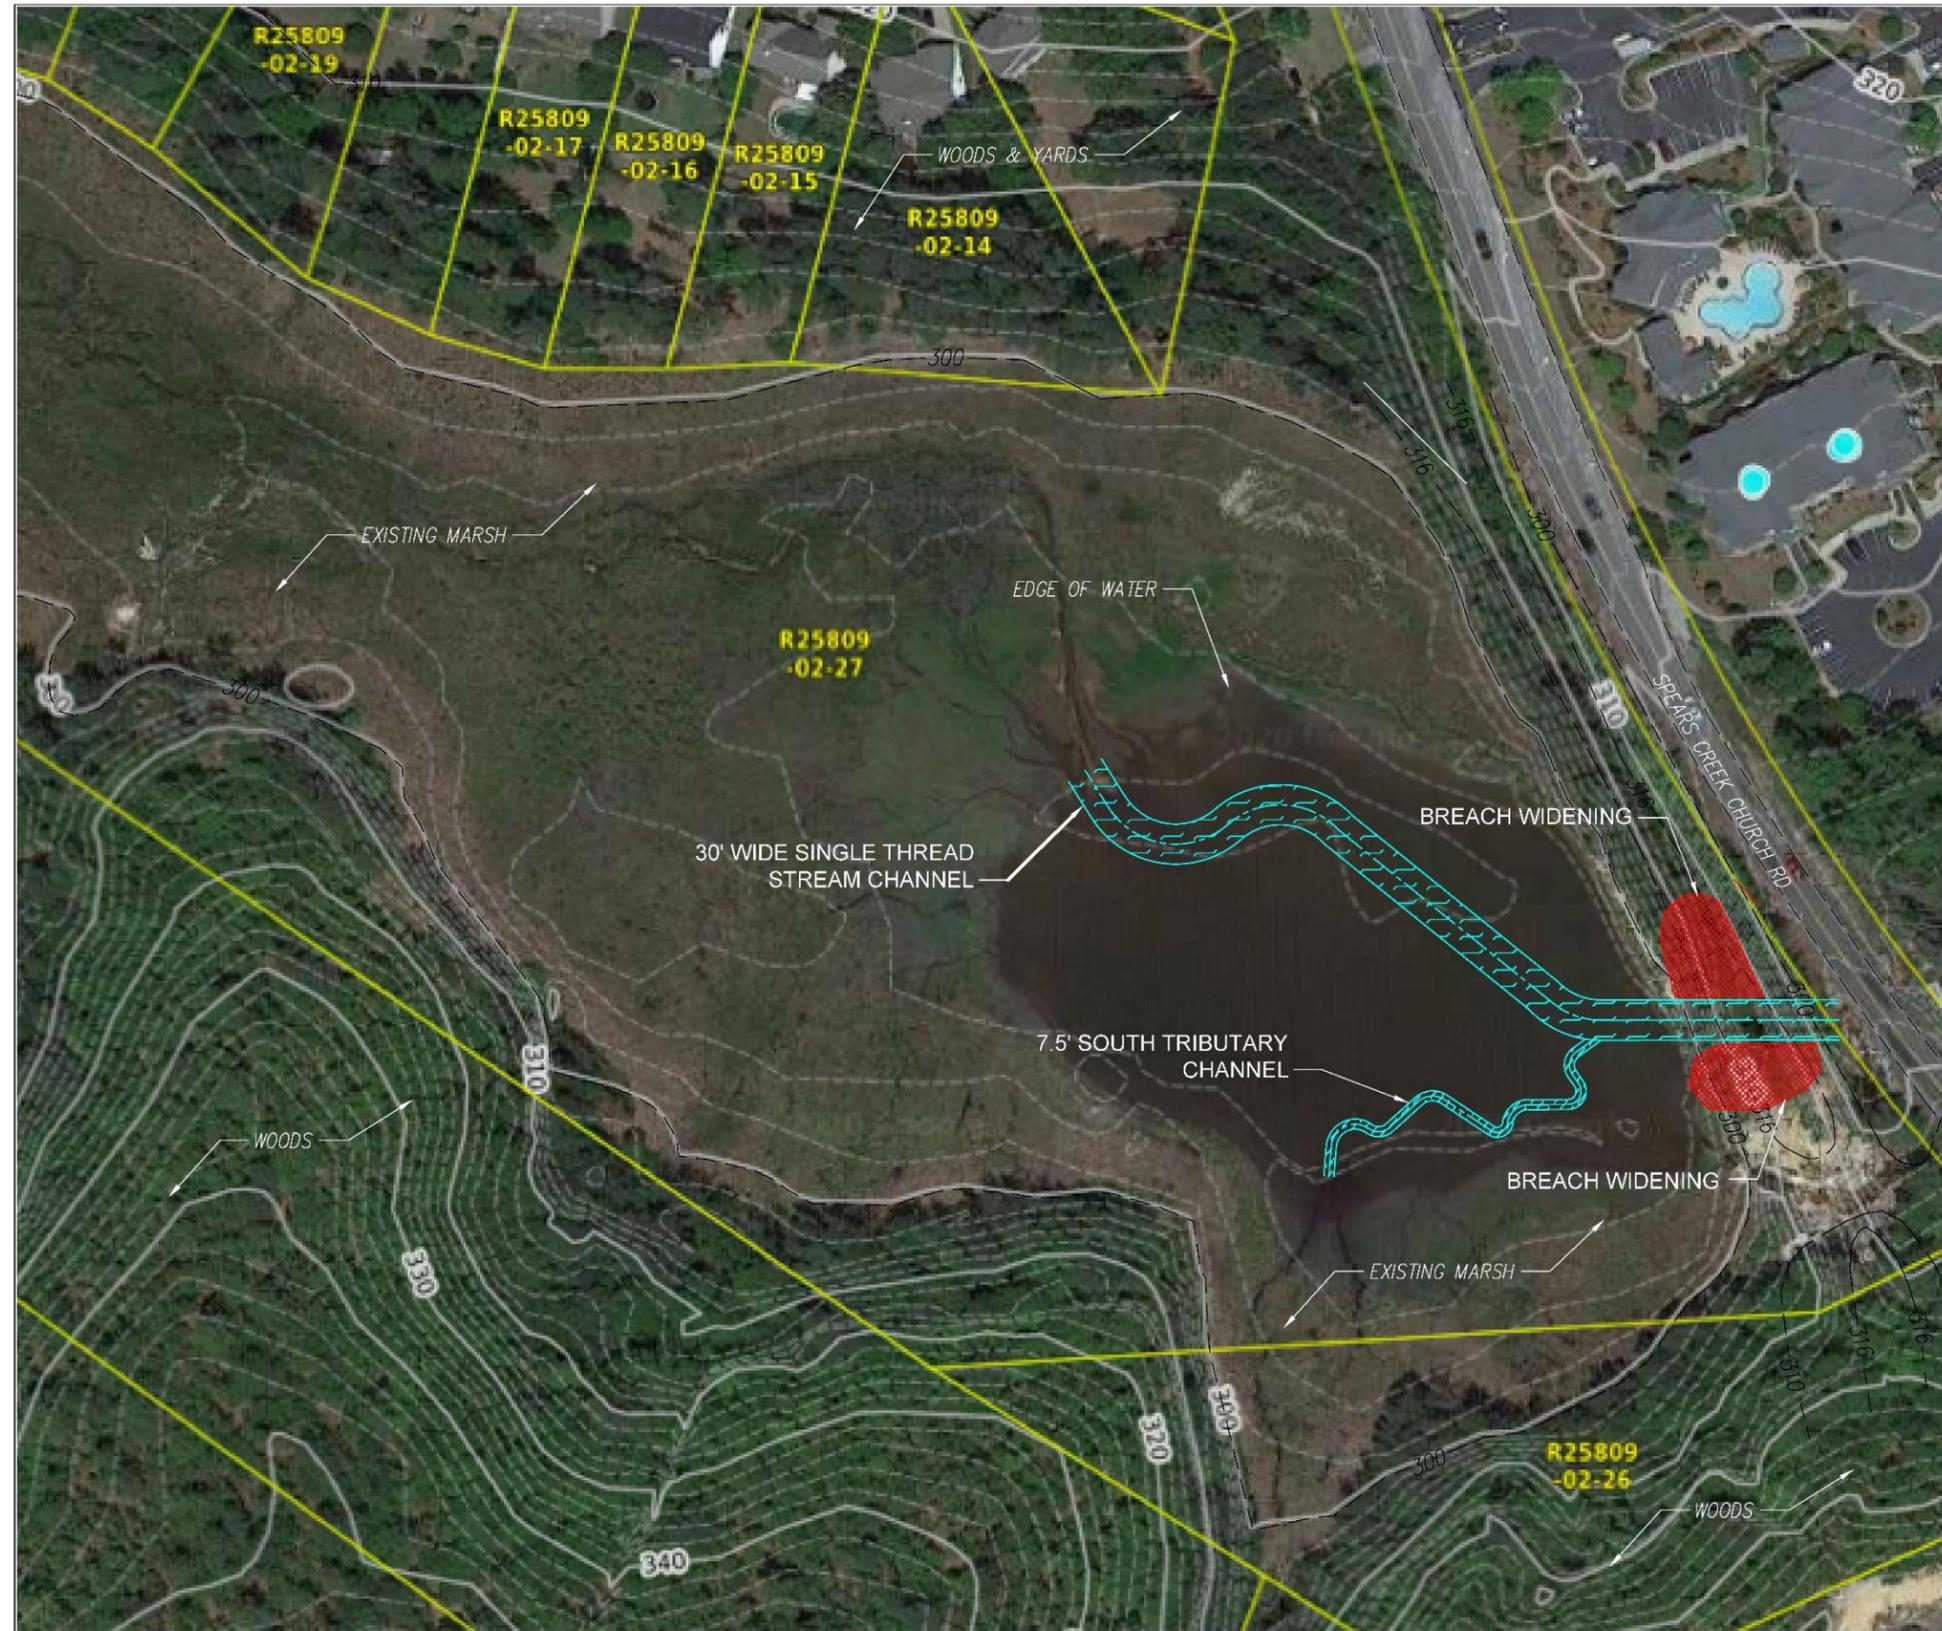
WALDEN POND CONCEPT DESIGN  
ALTERNATIVE 2  
RICHLAND COUNTY  
SOUTH CAROLINA

The conceptual design presented here would expand the dam breach to allow the stream to flow directly into the culverts at Spears Creek Church Road. As presently rendered, the elevation difference between the culverts and the upstream end of the stream would be distributed evenly along the entire channel length. This is probably the most cost-effective approach for both design and construction. Alternatively, the single-thread channel can be designed to include some cascade/step-pool features close to the road.

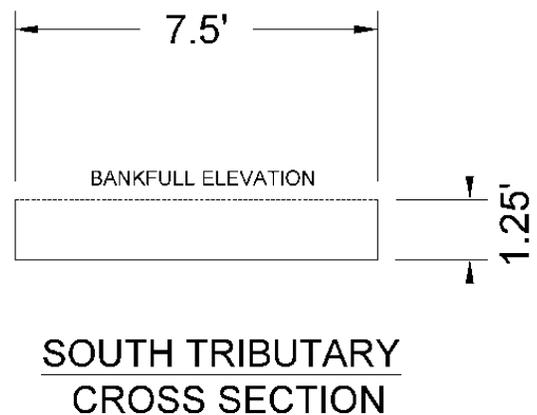
Figure 16. South tributary typical cross section.

A single thread channel design must also address the tributary entering the old pond from the south. Presently, flow from this tributary enters the remnant pool. The drainage area for the tributary is just under 20 acres. A concept design was developed to convey 35 ft<sup>3</sup>/second. Again, the channel is oversized, in this case both to accommodate sediment and also because of recent and anticipated development over a significant portion of the drainage area. As shown in the typical cross section below, the design depth is 1.25 feet. This shallow channel should help support the continued viability of emergent wetland vegetation on its floodplain. The dune height estimate for the south tributary is 0.16 ft. but is less important for this channel because it is not expected to receive large amounts of stored sediment.

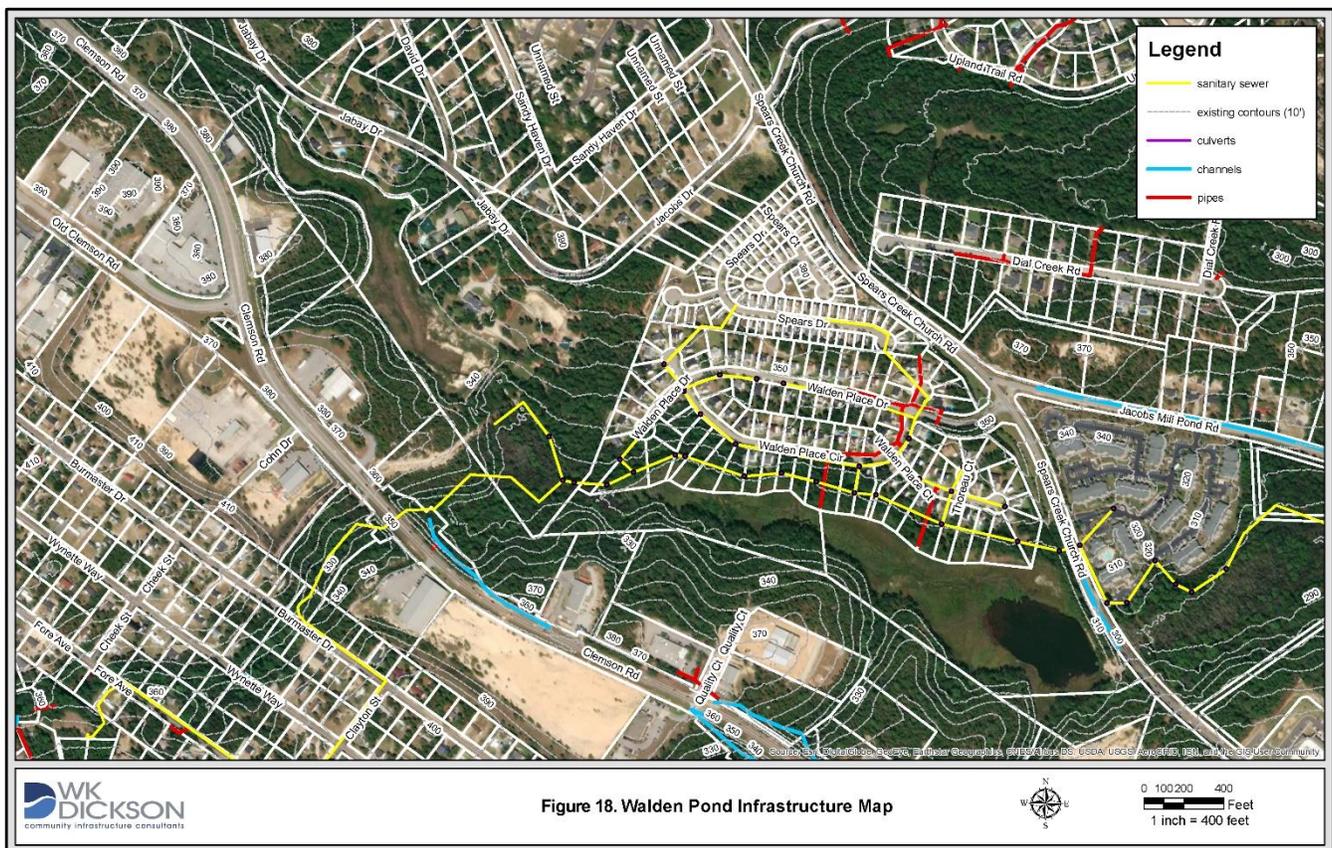
Figure 18. Walden Pond area infrastructure map.

- Utility conflicts: as shown in Figure 18 (below) no utility conflicts are apparent based on existing data.
- Fill material: both design alternatives would require some fill material to raise the bottom of the drained pond. Preliminary estimates indicate that over 11,000 yds<sup>3</sup> could be harvested by complete removal of the dam.
